HOUSATONIC RIVER BASIN

WATERBURY, CONNECTICUT

EAST MOUNTAIN RESERVOIR DAM CT 00032

PHASE I INSPECTION REPORT NATIONAL DAM INSPECTION PROGRAM

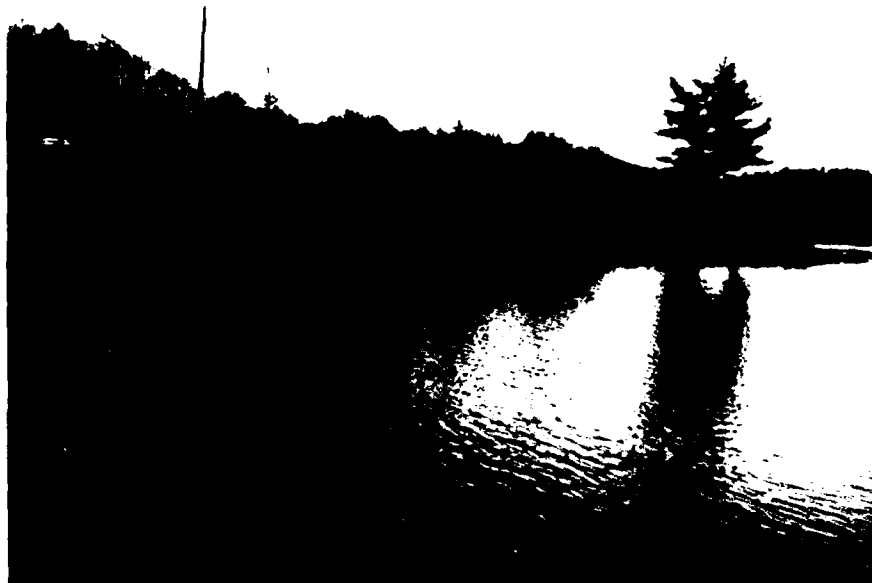
d. Reservoir Area - The area surrounding the reservoir is substantially developed and about 40% open. Route 69 runs along the eastern shore of the reservoir adjacent to the dam. There are several erosion zones along this portion of the shore where the masonry retaining walls constructed for bank reinforcing are cracked and falling into disrepair.

Photo 3 - Right shore of reservoir adjacent to dam

3. A comprehensive program of inspection by a registered professional engineer qualified in dam inspection should be instituted on a biennial basis.
4. Areas exposed by loss of riprap on the upstream slope of the dam and at the right bank of the reservoir adjacent to the dam, as well as the stone wall at the left side of the reservoir should be repaired to prevent erosion in the future.
